An Imperial Frontier of the Sasanian Empire: further fieldwork at the Great Wall of Gorgan

AN IMPERIAL FRONTIER OF THE SASANIAN EMPIRE: FURTHER FIELDWORK AT THE GREAT WALL OF GORGAN

Source: *Iran*, Vol. 45 (2007), pp. 95-136

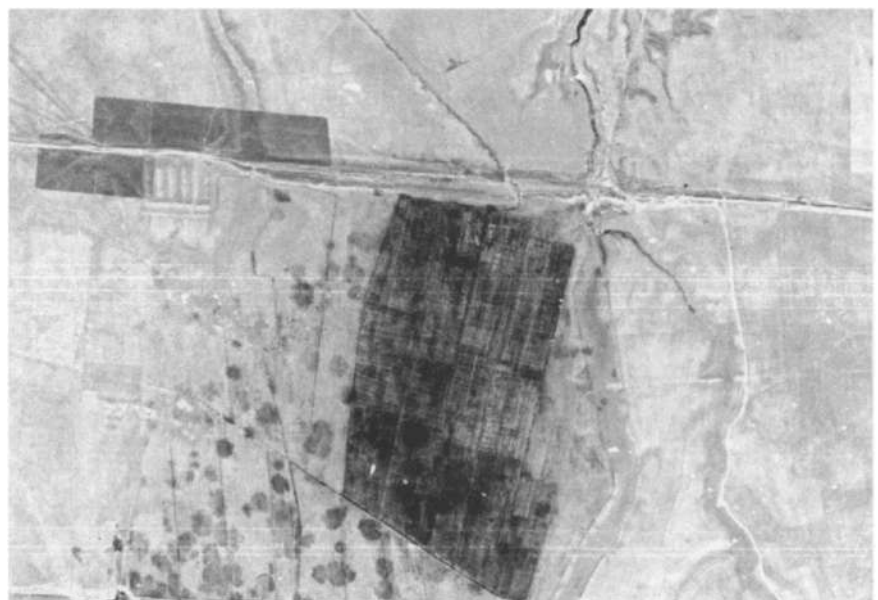
Fig. 2. Area of embanking along the wall (the alignment parallel to the top border) with Fort 15, the rectangular enclosure near the left margin, abutting the wall. Four parallel stripes are visible in the interior, at right angles to the wall. CORONA image by courtesy of US Geological Survey, with permission.

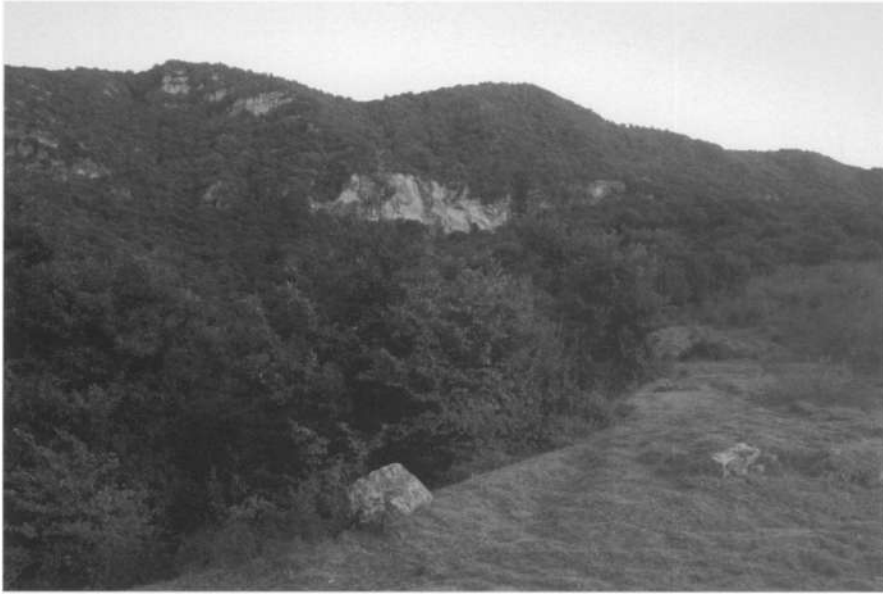
Fig. 5. The Great Wall of Gorgan, marked by a scatter of fragments of the typical bricks, follows the grass-covered ridge in the foreground, overlooking a deep valley to the left, and extends to the vicinity of the vertical rock face in the Elburz Mountains in the background (or possibly beyond).

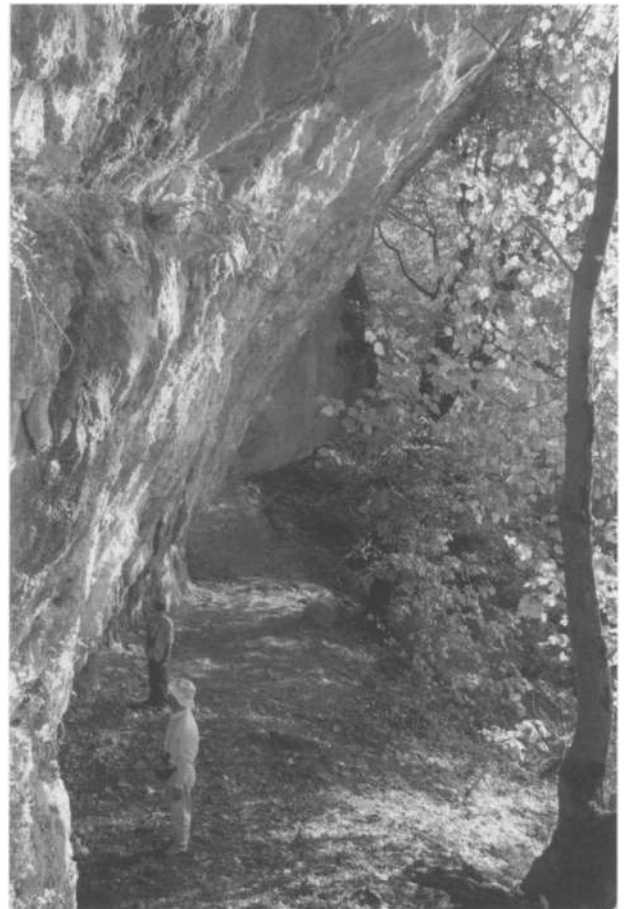
Fig. 6. The overhanging rock, marking a possible terminal of the wall (see Fig. 22), would have formed a substantial obstacle.

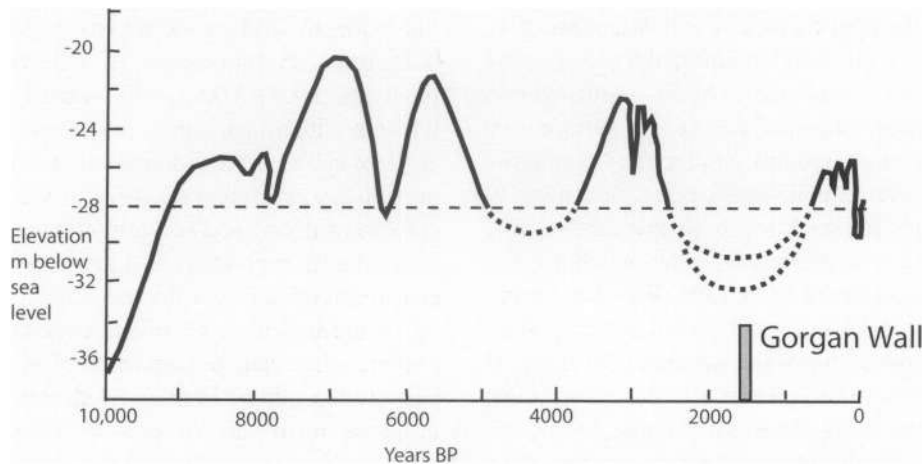
Fig. 10. Caspian Sea level curve with main phase of Gorgan Wall indicated (rectangle), based on Rychagov 1997: fig. 5.

correspond to this inundation were a series of transgressions that reached *c.* -22 m. between *c.* 500 years ago and the present day (Fig. 10). The shells from context I.004 have now yielded a radiocarbon date of A.D. 1344–1460 at 95.4% confidence level² for the initial transgression. Although this high sea stand corresponds chronologically to that of Rychagov, the elevation of the equivalent event along the Gorgan wall, at -22 m., is some 3 m. higher than Rychagov's estimate. Further dates and field studies are therefore required from the Gorgan Wall Project in order to sort out some of these contradictions.

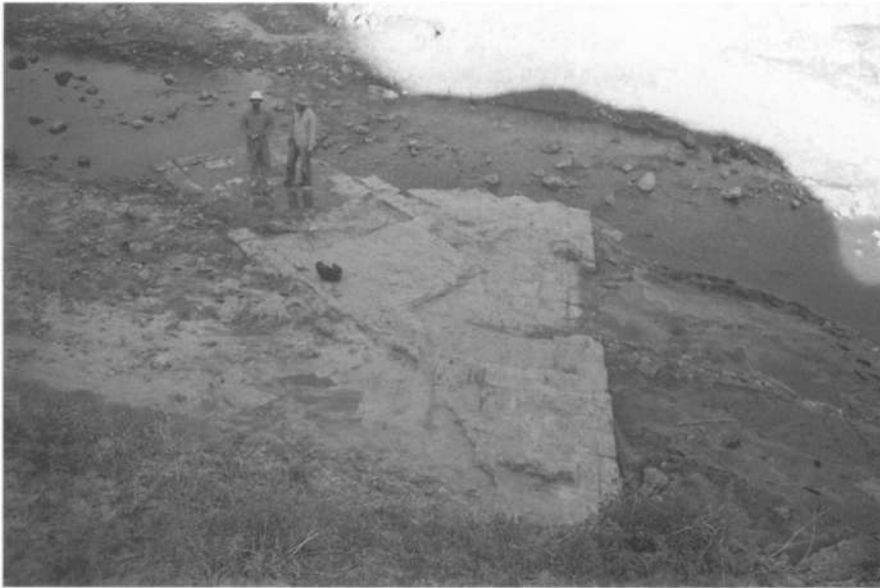
Fig. 14. Feature of Gorgan Wall bricks at east end of wall between Fort 2 and 2A. (See Fig. 13 for its location.)

In the floor of the valley of the Sari Seyyid River, an apparent part of the Gorgan Wall complex has been noted (by Hamid Omrani). This substantial feature of fired brick (Figs 13, “WP 438” and 14) is located in the bed of the flowing river. It consists of two lengths of wall or platform made of Gorgan Wall fired bricks. The first oriented at 233 degrees magnetic is at right angles to the main channel of the river, whereas the second

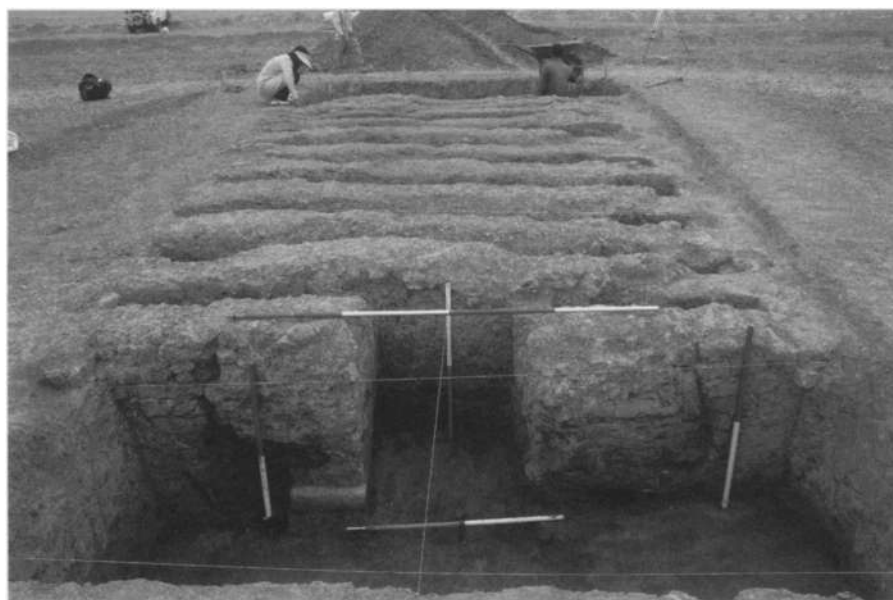
Fig. 20. The kiln in Trench G seen from the south. Each segment of the scales corresponds to 0.50 m.

The southern and northern side of the kiln were excavated, but virtually none of the interior, except for a small sondage in the south (Figs 17 and 20). In the light

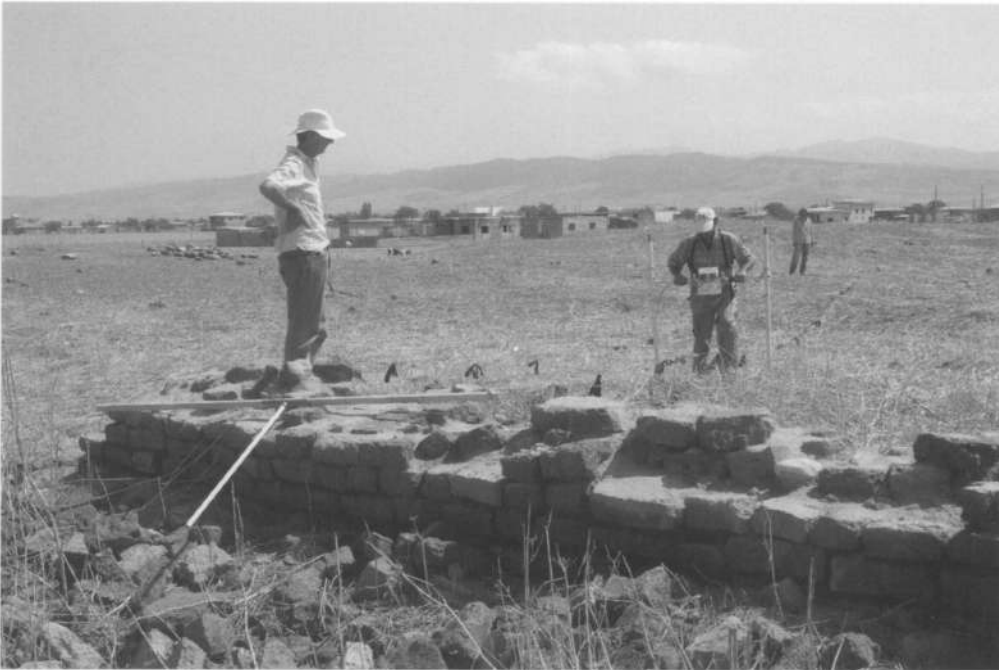
Fig. 23. A modern burial enclosure made of reused Gorgan Wall bricks (see Fig. 22) and the magnetometer survey in progress.

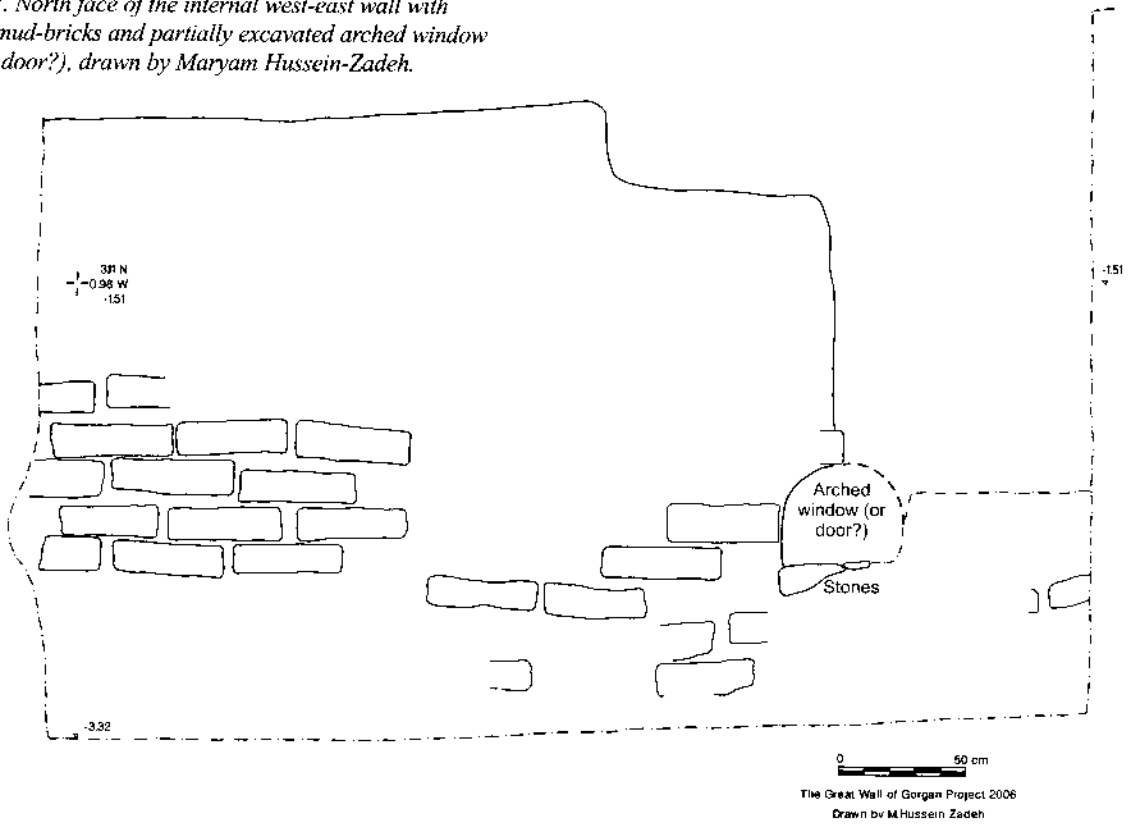
Fig. 27. North face of the internal west-east wall with preserved mud-bricks and partially excavated arched window (or door?), drawn by Maryam Hussein-Zadeh.

Between the rooms we found one arched window (or door?) opening (Fig. 27), first observed by Esmail Safari, which could not be fully explored for safety reasons, because of the substantial weight of the overhanging wall. We are thus unsure whether the stones (Fig. 27) mark the bottom of a c. 0.40 m. high window or whether it was an up to 1.40 m. high doorway, blocked later. During the latest phase of occupation (see below), all of this would have been below ground. The initial connection of the two rooms (whether passable for a person or not) would have facilitated communication between the rooms. Practical advantages in passing messages or goods from one room to another may have been the sole reason for the door or window. It is, however, also conceivable that it might have been intended as a control mechanism, so as to make it more difficult for ordinary soldiers to secretly discuss any grievances with each other.

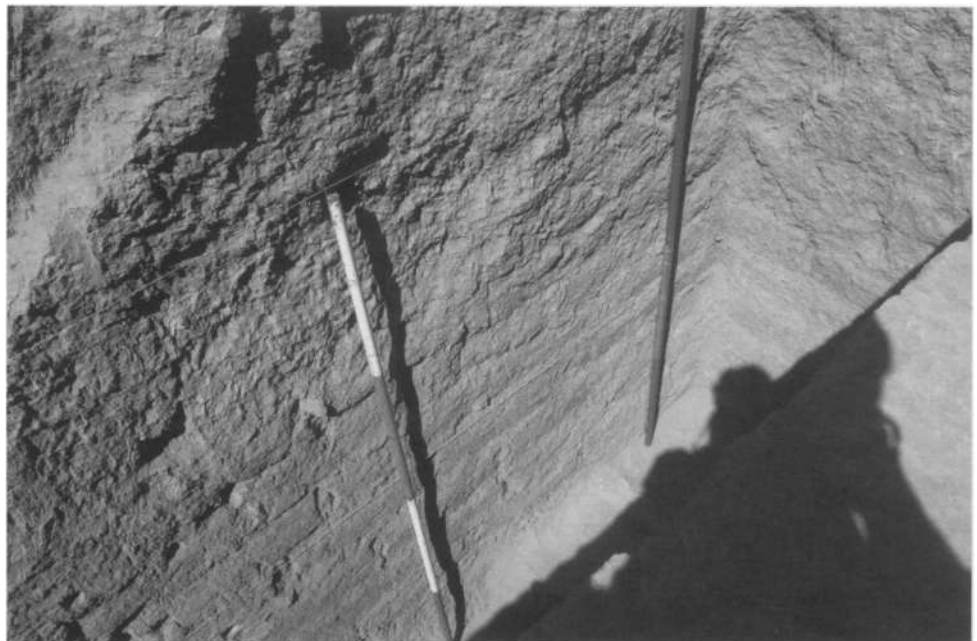
Fig. 30. The north-east corner of the southern room with preserved mud-bricks.

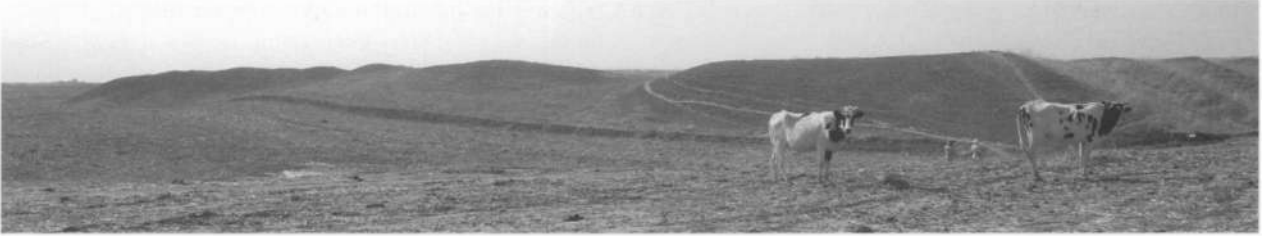
Fig. 31. Fort 4 (like the other forts on the Gorgan Wall) forms a substantial platform, here the small side seen from the south-east. Note the human scales (between the cows) in close vicinity to the fort.
